## Your Home USA

**Inspection Date:**  
Your Choice

**Prepared For:**  
John Doe

**Prepared By:**  
Flagstaff Home Inspections  
Flagstaff, AZ

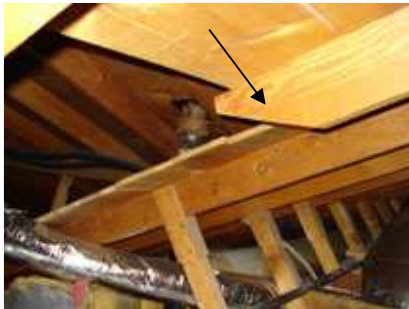
- **Repair:** A site built roof truss, located near the attic access, has been cut or altered which may affect its integrity. Trusses should not be modified without special engineering of additional support. Although no significant movement was observed in this area at the time of the inspection, it is recommended a properly engineered repair be performed by a licensed contractor.

Cut Truss

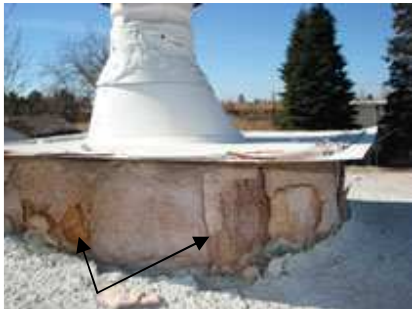
Deteriorated Flue Tile

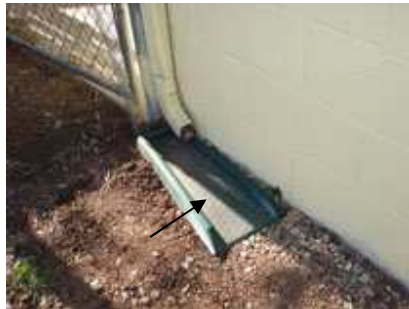
Downspout Discharge Next to House

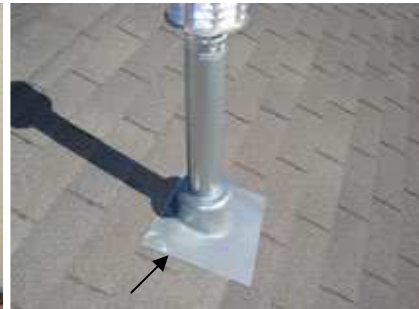
- **Repair:** The water heater exhaust vent roof flashing has been installed in a fashion that may make it prone to leakage. Shingles should lap over the top and sides of the flashing. The sides of the flashing were exposed. Recommend improvement.
- **Improve:** Ideally the gutter downspout(s) should discharge water a few feet from the house. Recommend roof water be encouraged to flow away from the building at the point of discharge by adding extensions or splash blocks at the downspouts.
- **Improve:** The rear porch gutter does not appear to have sufficient slope to drain properly. Recommend improvement so improperly sloped areas drain properly.
- **Repair:** The short section of fireplace flue tile extending above the top of the chimney is deteriorated. Recommend further investigation and repair by a chimney specialist or licensed contractor.

Water Heater Roof Flashing Exposed

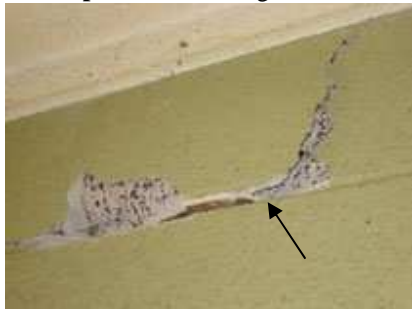
- **Monitor:** A damaged concrete block was observed at the top of the south wall in the rear shop. It appears this occurred when a ceiling beam was added in the master bedroom. Recommend this area be monitored or further inspected.

Cracked Block

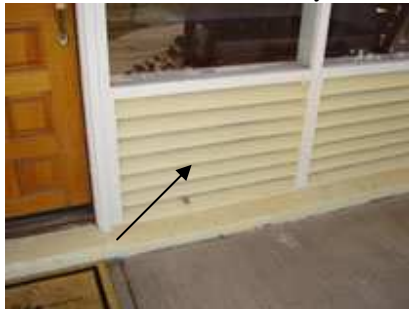
Louvers Front Exterior

- **Improve:** Screened louvers have been installed under the front single pane fixed glass windows. Plywood panels on the inside of the home are designed to hinge open to allow air through the louvers. This area most likely allows cold to pass into the house interior. Recommend the louvered area be covered and insulated, and the windows replaced with screened opening dual pane windows to prevent heat loss through this area.

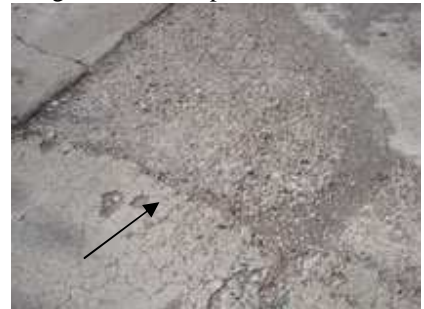
- **Improve:** Areas of surface deterioration were observed in the driveway. This type of damage is usually caused by moisture in the surface of the slab which has frozen and expanded, separating the top layer of concrete from the slab. The application of concrete patch material usually is only a short term fix. Depending on how severe the problem is, replacement is usually the ultimate solution.

Driveway Deterioration

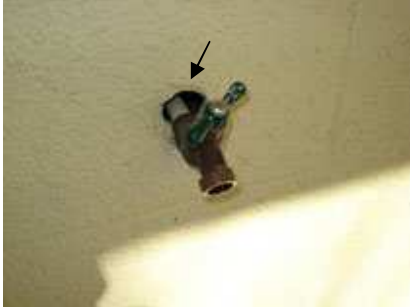
- **Repair:** A hole or opening was observed around the rear exterior hose bib. Recommend a permanent, professional repair to prevent moisture from entering the wall.

**Hole in Block Around Faucet**

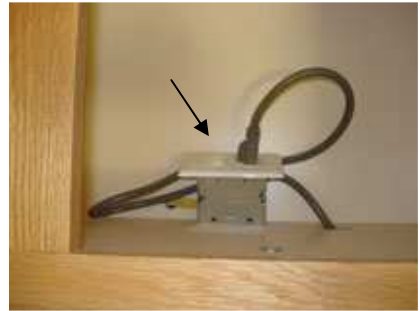
- **Repair:** A loose outlet box was observed in the cabinet above the range. Recommend the box be properly secured and the wiring protected.

Loose Box

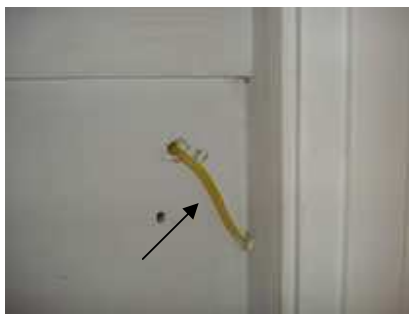
- **Safety Issue:** Unprotected wiring was observed in the front entry and SW bedroom closets, and the rear shop. For added safety, recommend wiring exposed on interior or exterior finishes be relocated inside walls or protected by conduit.

Unprotected Wiring

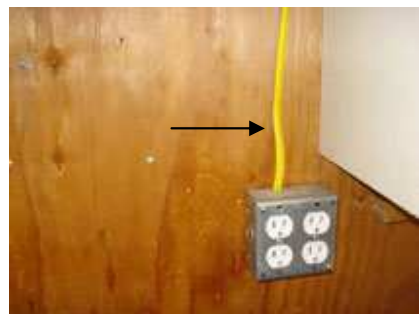
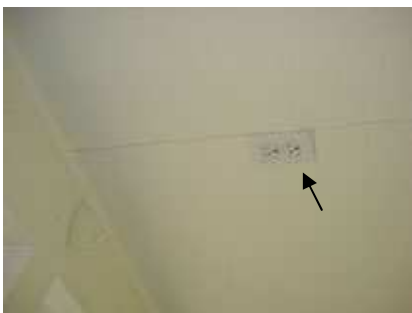
Missing Weather Covers

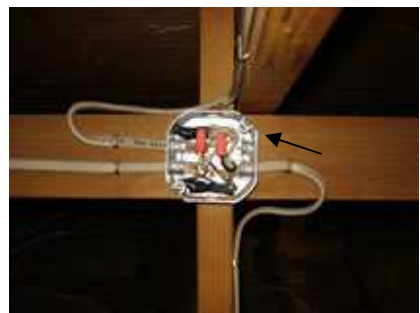
- **Improve:** An open junction box was observed in the attic above the master bedroom. Recommend all junction boxes be fitted with cover plates, in order to protect the wire connections.

Open Junction Box

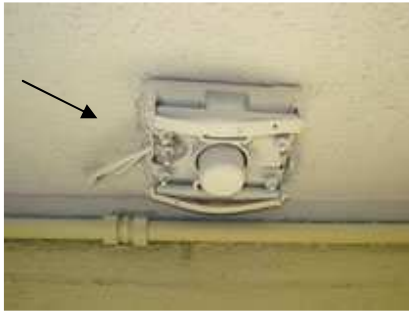
- **Improve:** The rear porch ceiling light was covered with tape. Recommend tape be removed.
- **Improve:** Recommend a cover be installed on the phone box in the east eave if this box is currently being used.

- **Phone Box Cover Missing**

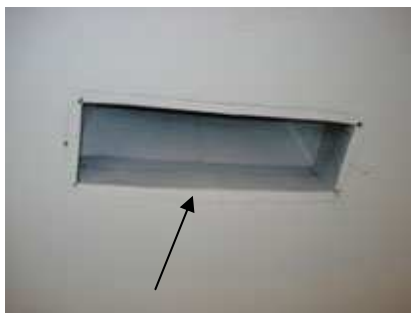
- **Improve:** The louvered registers for many of the ceiling heating duct were missing. Recommend registers be installed where missing.
- **Improve:** The master bedroom west ceiling supply vent had less air pressure than other vents. Balancing the system air flow can sometimes be accomplished by closing down the louvers on grills where pressure is high or not needed. If this does not improve air pressure, a heating contractor should be consulted for further investigation and improvements.
- **Improve:** Because the furnace thermostat is located in the area of the front entry door, cold air from opening of the door can adversely affect the operation of the heating system. Recommend the thermostat be located in an area away from exterior doors.

Ceiling Grills Missing Various Rooms

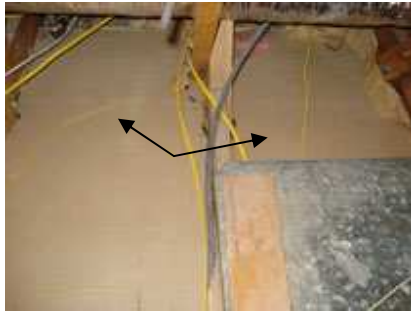
- **Improve:** Missing attic insulation was observed in areas above the kitchen and hallway. Recommend insulation be installed where missing.

**Missing Ceiling Insulation**

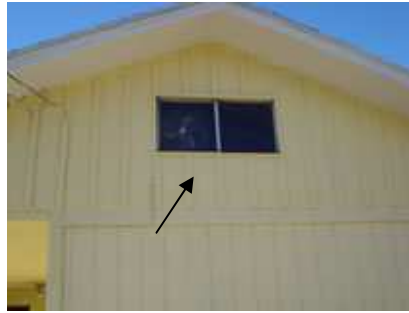
- **Improve:** Attic ventilation consists of 3 roof vents and a window at the rear gable end that opens. A fan has been installed in front of the window in the attic. If the window is not open, cross ventilation is inadequate. To open the window, one must enter the attic. An open window could allow access by birds, animals and insects. Recommend the window be replaced with a screened gable end vent, and soffit vents added to allow for adequate cross ventilation. Recommend further investigation and improvement by a licensed contractor.

**Replace Window With Gable Vent**

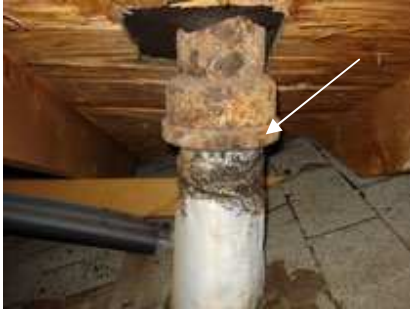
Plumbing Vent Loose Connection

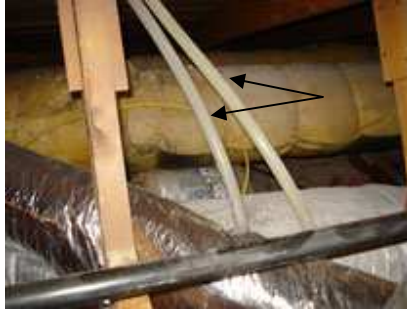
- **Improve:** Recommend exposed water heater supply lines in the attic be insulated where missing to prevent freezing. Areas of missing pipe insulation were observed near the attic access.

Attic Supply Piping Not Insulated

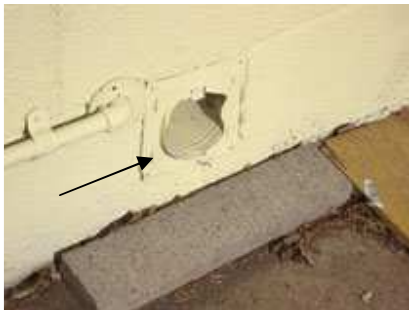
- **Repair:** Recommend a clothes dryer vent hood be installed where the dryer vent pipe terminates on the exterior wall.

**Dryer Vent Hood Missing**
